Kingpin and Skid Plate Safety and Security – Steve Bullôt

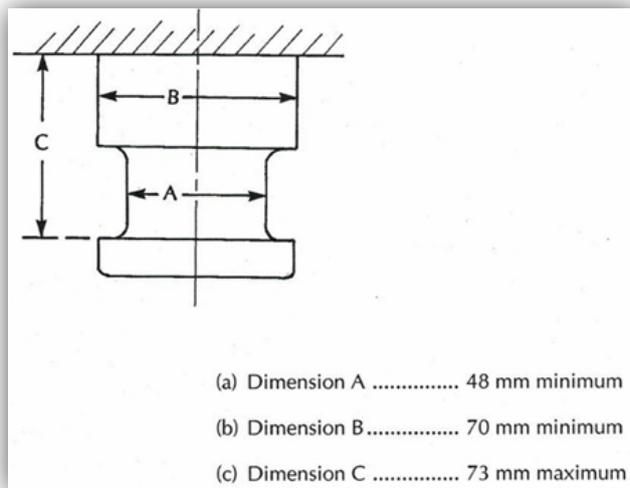
The kingpin is the critical single point of connection between the trailer and the tractor unit and must be in good condition, not damaged or bent and mounted square and not worn outside the dimensional limits as stated in the Standard NZS 5451 (Specification for Coupling Devices for Articulated Vehicles). Appropriate gauges should be used to check before completing form 4085B, The NZTA Operator statement of skidplate maintenance that must be presented when the vehicle is presented for a CoF. Note that this form must be correctly filled in and have been completed no more than 30 days/15,000 km prior

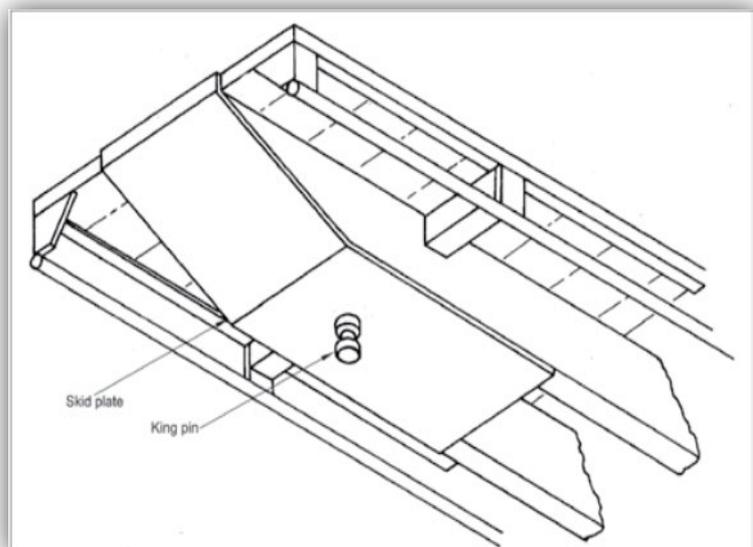
The skid plate, also known as the rubbing plate, is an integral part of the structure of the trailer that supports the kingpin. The skid plate should be designed so that it remains flat & level throughout the life of the trailer. If the skid plate buckles or warps outside the limits in the Standard then the kingpin may not locate in the jaws of the 5th wheel correctly and the combination could separate catastrophically. The design of the skid plate as part of the trailer should enable inspection of the kingpin mount, the structure of the skid plate and facilitate drainage so moisture is not trapped promoting corrosion. This may require the inclusion of inspection holes or an inspection hatch.

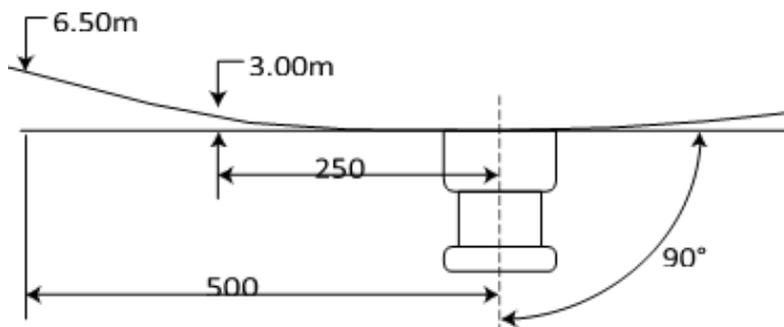
The key to kingpin/skid plate safety is regular and careful inspection. The combination should be separated and cleaned then checked for corrosion, especially behind the skid plate. The skid plate should then be checked for cracking or damage and the supporting structure checked to ensure it is still fit for purpose.

The skid plate can then be checked for flatness against the requirements in the Standard and the kingpin checked for square and wear.

Images from NZS 5451:1989

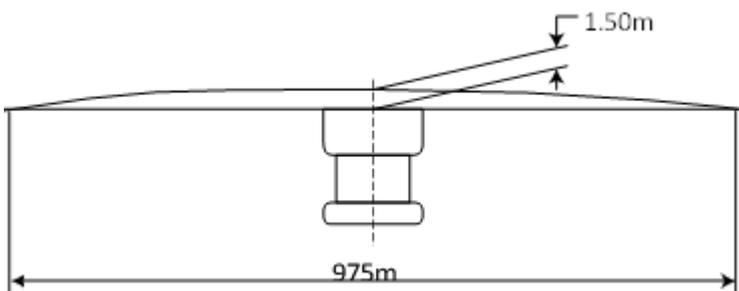
Note: that refrigerated and monocoque semi-trailers are at greatest risk of failure from corrosion, cracking or distortion due to the fact that the skid plate support structure is often difficult to inspect and it is easier for moisture & debris to collect behind the skid plate.

It is critical that there is a regular maintenance schedule when tractors and their semis are split for inspection. The use of the correct gauges to inspect for flatness of the skid plate and the squareness of kingpin is important as is keeping proper maintenance records that can provide a history of failure and repair and inform risk.
